Report on HS2 Ltd's Bowood Lane Mitigation site

HS2 Responses shown in Green

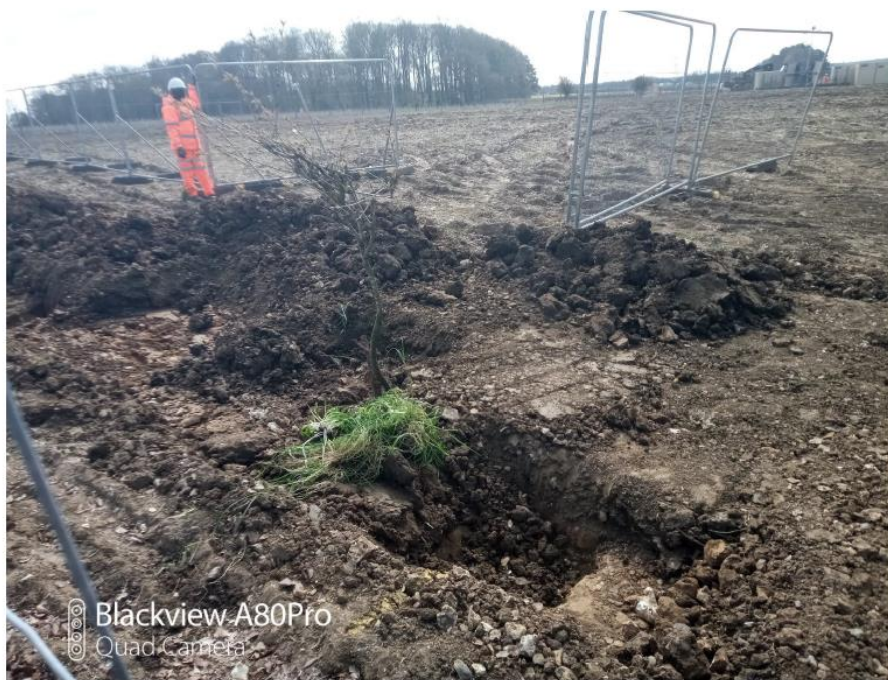
Fig 2

The receptor site host soil was compacted (Fig 2) pretty much daily with heavy machinery over the whole of winter '20/21 and was waterlogged much of that time. This was never ameliorated.

Trial holes of the subsoil at the receptor site were undertaken under the supervision of a qualified soil scientist. This identified some damage to the topsoil in the receptor site location. The surveys identified no damage to the subsoils at the receptor site. All receptor site topsoil was progressively removed prior to the ancient woodland soil transfer taking place with regular inspection of soils undertaken.

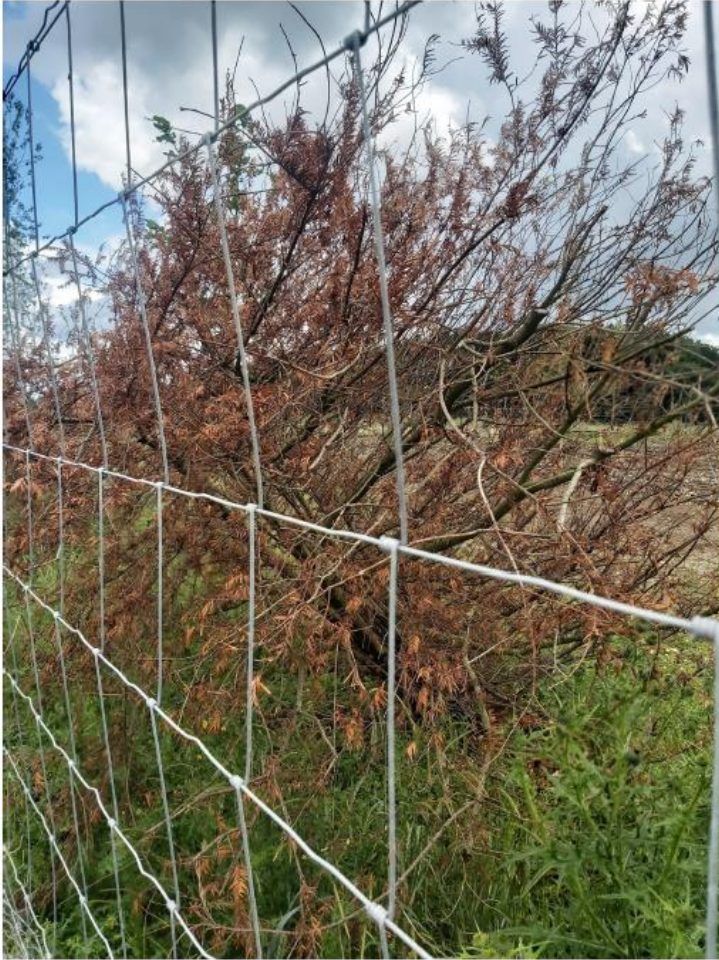
Fig 3

Of the translocated ancient hedge, it appears one plant is surviving, six barely surviving and unlikely to succeed. The other seventeen are quite dead including yews and hollies (Fig 3).

Existing Hedgerow was moved from the woodland edge to provide height and connectivity from the retained hedgerow and to retain soils within the root structure of existing hedgerow.

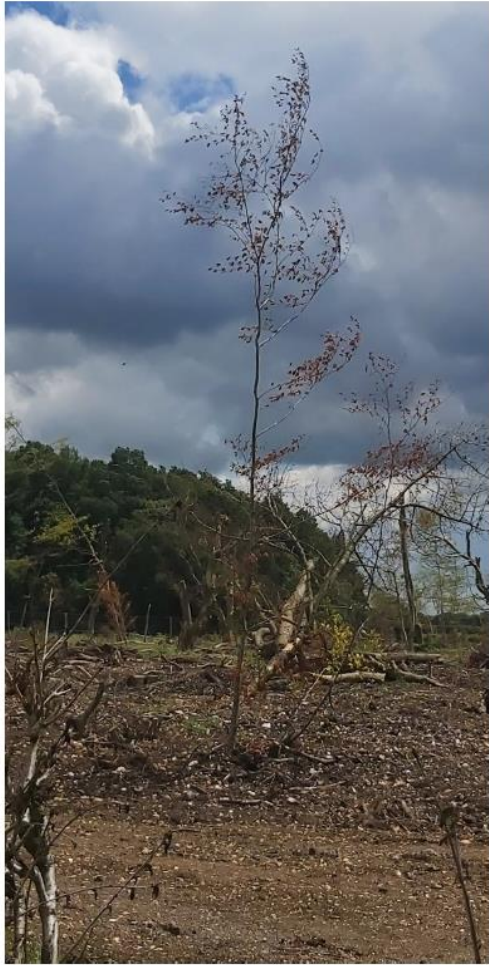
Fig 4

Few if any of the translocated trees taken for live specimens in the site have survived (Fig 4). In the receptor site there is a large empty space possibly equivalent to over a third the total area suggesting the area of mitigation falls well short of area of woodland destroyed (Fig 5) In addition to this the long new front to the ancient woodland, composed of newly exposed etiolated weak trees suggests that there will be much secondary damage unaccounted for in ecologists assessments.

All monolith and existing trees are relocated to provide vertical diversity within the site. Existing trees are translocated with the intention of survival. Should trees not survive they along with monoliths provide important standing deadwood features with ecological value.

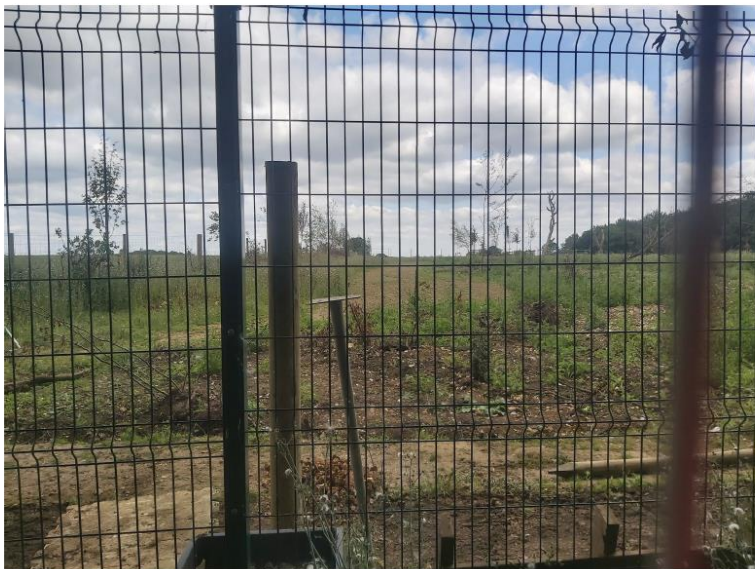
Fig 5

9% (600m²) of the woodland soils were not translocated as the woodland soils were found to be substandard following previous protestor habitation, the required security operation or due to increased nutrient and intensity of weeds within the donor site. For clarity the woodland salvaged soils were placed at the same thickness and layer composition as per the donor site.

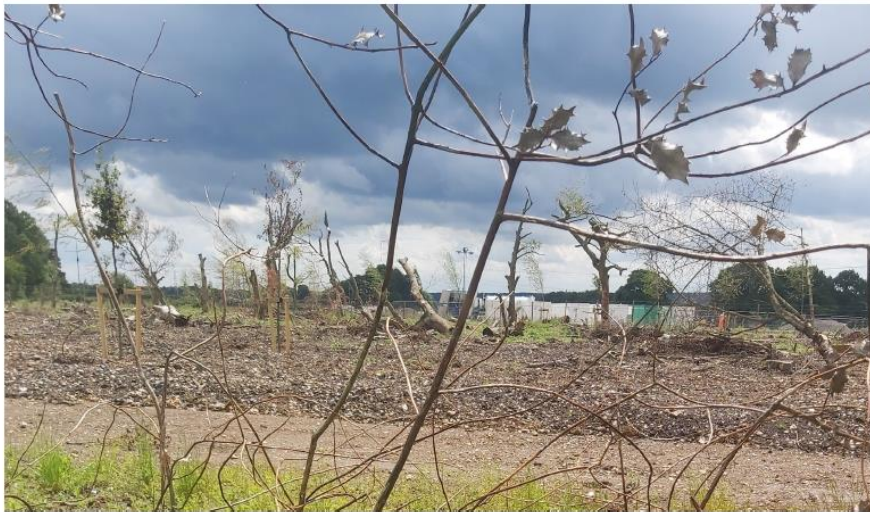
Fig 7

The supposed bat flightline trees within the receptor site are, as far as bats are likely concerned, lost amid a jumble of erratically placed considerably larger trees and monoliths (Fig 7).

The bat flight line was installed as per Licence conditions and provides a continuous line. Monoliths and larger relocated trees provide further ecological benefits in a random layout reflecting their position in the former woodland.

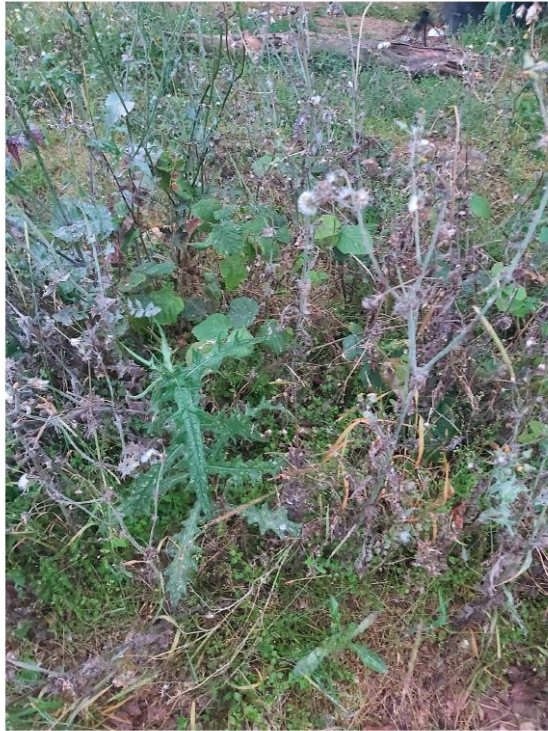
Fig 8

There are many smaller whips and pot grown plants added to the hedge and throughout the translocated site. These tend to be deep in weeds so only a rough estimate of around 25 - 30% attrition can be given (Fig 8)

Herbicides have been used to control weeds to avoid impact to new planting within the planting site. The planting site is managed in line with the ecological site maintenance plan and performing in line with expectations

Trees transplanted into the ancient woodland soils are expected to supplement natural regeneration and weed growth is part of the regeneration phase and not artificially managed with herbicide.

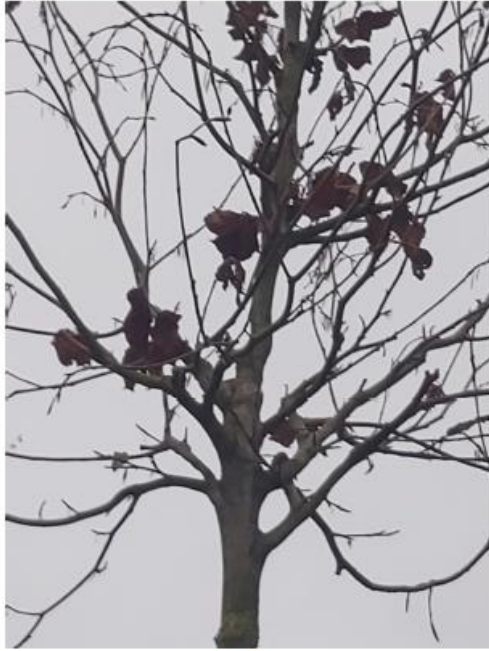
Fig 9

There are two main lines of nursery grown semi-mature trees planted as flight corridors for bats, planted across the receptor site and the woodland planting site. Within the receptor site, as mentioned above, it is unlikely that these trees form any legible guide to bats (Fig 7). The majority of these trees appear heading toward untimely death. (Fig 9, Fig 10)

The Bat Licence holder has continued to attend the site during construction and following completion. They are satisfied works are within the licence conditions.

Any failure of planted trees will be replaced in the Optimum Winter 2021/2022 planting season. Ongoing upkeep of the Bat flight line is stated as a Licence condition.

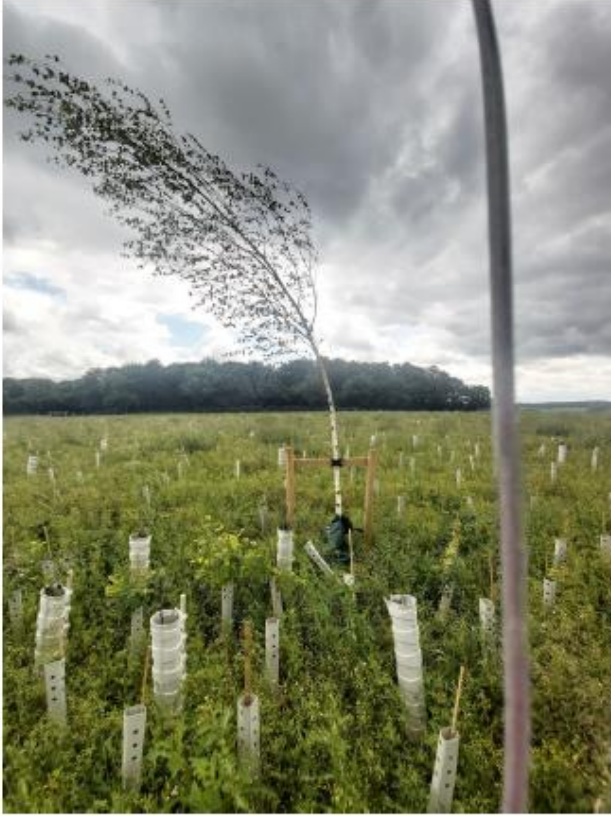
Fig 11

Along the contiguous northern perimeter of the receptor site and woodland planting site there are 37 of these trees, all with watering bags, but 24 are stressed to very stressed with a 10 probably dead. Many of these despite being given quite substantial supports (some months after planting) are leaning at precarious angles (Fig 11) and, furthermore, the ties to those supports are poorly executed (Fig 12) with only a small handful of trees actually benefitting from that support. Most will soon be seriously damaged by chafing at a critical height as wind rocks the trees on the hard supports. The water bags have only been seen being filled twice since planting in April.

Substandard tree ties were identified and will be rectified this planting season (2021/2022).

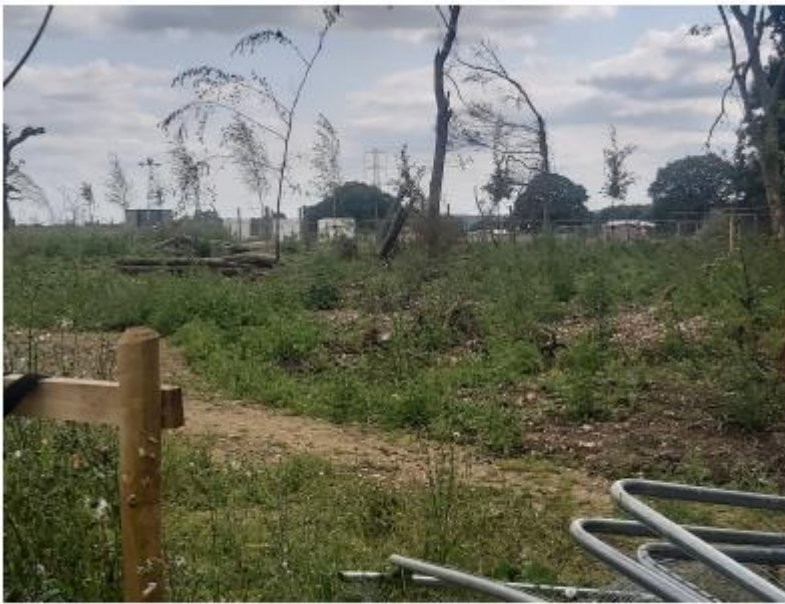
Fig 13

The second line of trees runs diagonally from Jones' Hill Wood to the unnamed wood at top of Bowood La. From a standpoint behind the northern fence, only 14 are assessable. 8 of those are clearly stressed, some possibly dead. 7 are close enough for the base of the tree to be discernable, and there are no water bags to be seen (Fig 13). Supports and tying follows the same pattern as above.

There appears to have been an application of herbicide along the north and east hedge boundaries (Fig 13), possibly to reduce wind blown seed contaminating adjacent agricultural land. If this is the case it looks to be a futile underperformance. There is a very considerable seed bank here which the local farmer must wince painfully when he sees.

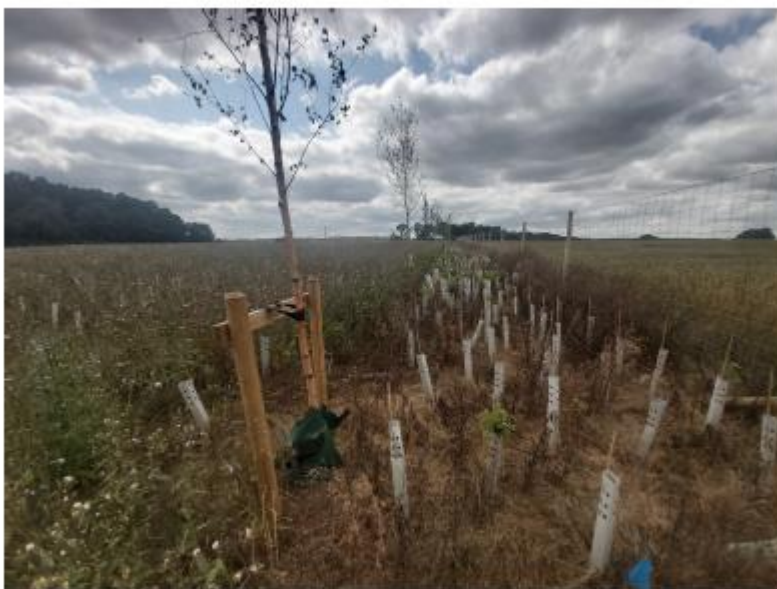
Fig 14

Plans I have seen show hedging along a serpentine edge to the fence line, but what has appeared is a straight line (Fig 14).

Hedgerow planting is in accordance with the construction issued drawing and superseded by Bat Licence conditions.

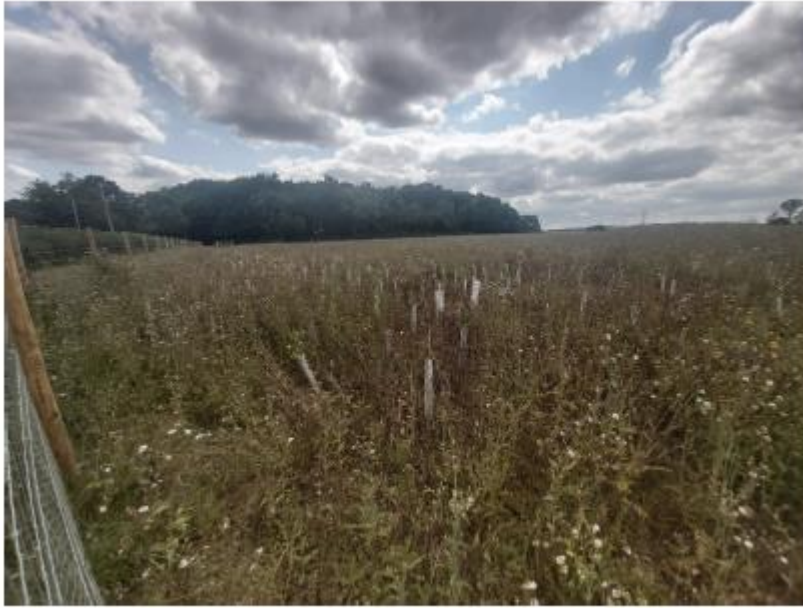
Fig 15

Most of the area is under a major infestation of weeds with the majority of whips quite invisible (Fig 15).

HS2 have committed to replace the majority of failed trees over a five-year period during the establishment of the woodland. A natural thinning out is planned as the woodland matures so a low level of attrition is accepted. Current assessments reflect a 25% failure rate, this is as expected for an exposed hillside site.

Understory woodland Management is being carried out as per Maintenance schedule. Weeds competing with planting are treated with herbicide. Weed treatment was undertaken in the Autumn and will continue to be managed. Assessment of wildflower mix indicates performance meeting expectation.

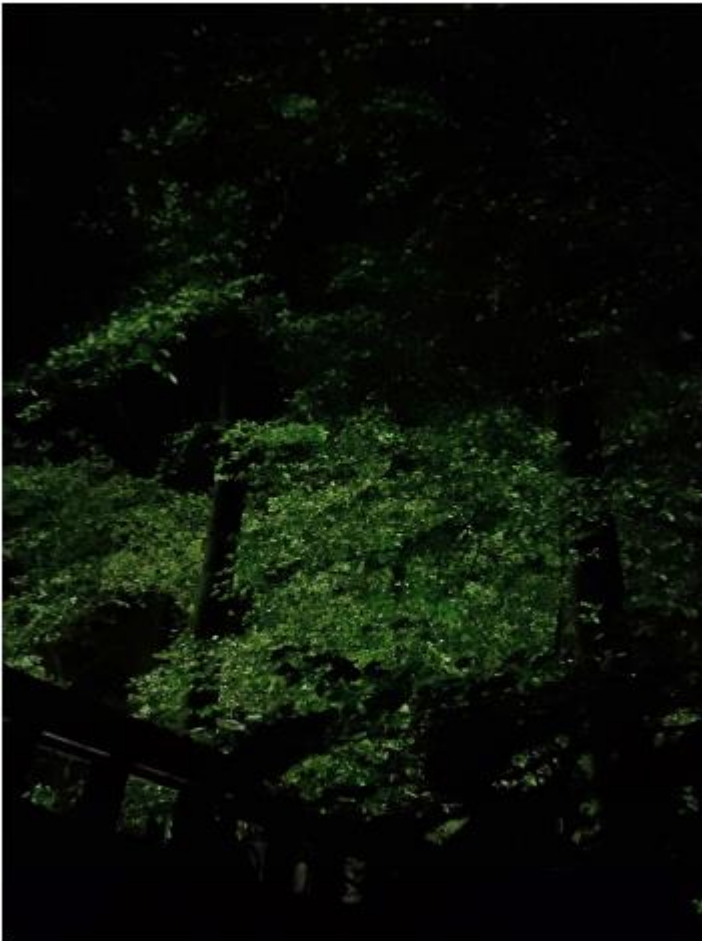
Fig16

Still this beleaguered strip that is now a wide open front to the Wood is floodlit every night (Fig 16), though lamp numbers have been reduced. The noisy generators now only run at night, coming on after sun down.

Due to presence of personnel onsite during hours of darkness, lighting is required to ensure their safety and wellbeing.

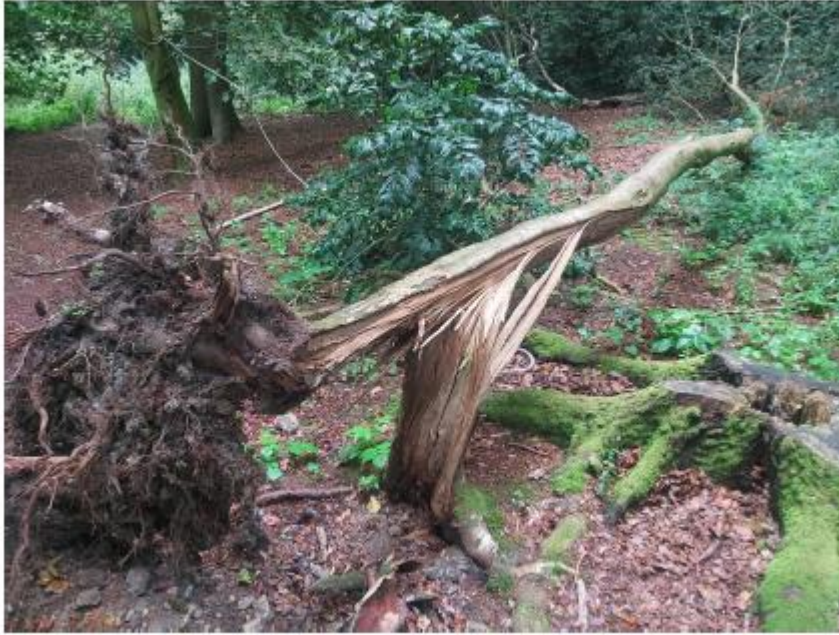
Fig 17

The retained woodland facing the removed woodland forms the Woodland Edge Management Zone and falls within Act limits. This zone will continue to be monitored and managed. An arboricultural survey was carried out and trees within this zone assessed to be wind firm and will continued to be monitored. Fallen trees outside of Act limits are the responsibility of the Landowner.

As mentioned above, the Wood now has a very wide open front allowing light and weather penetrate right through the heart of the Wood and already some weaker specimens on the supposedly safe side have sadly succumbed (Fig 17).
