Incident Report: Crossing of the River Misbourne by the Chiltern Tunnel.

1MC05-ALJ-EV-REP-CS02_CL04-000228

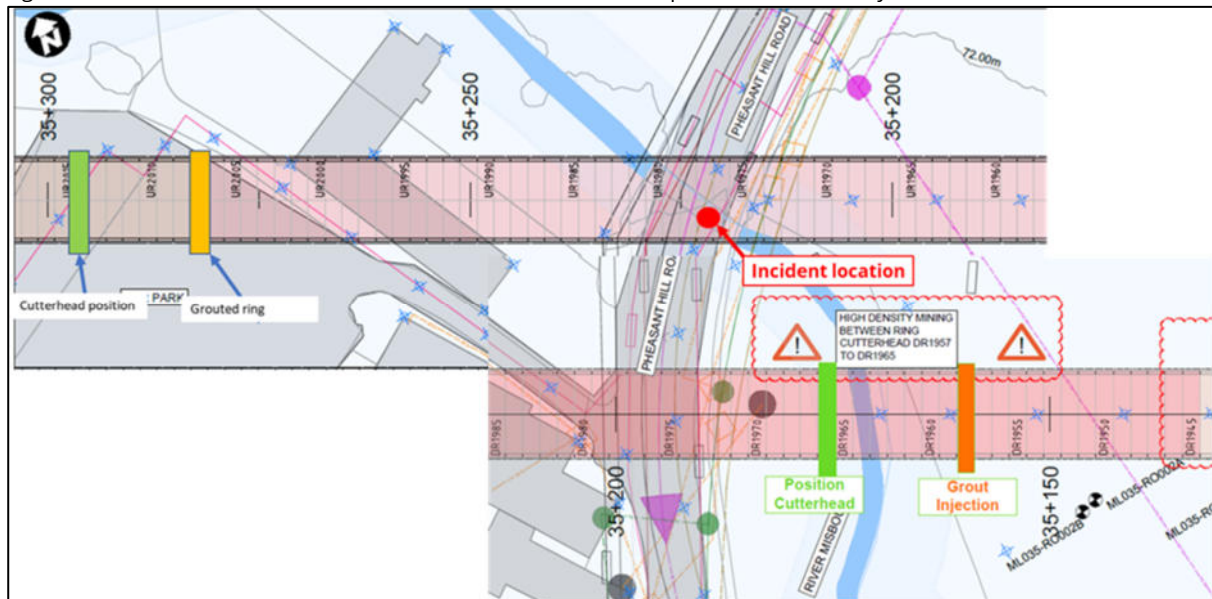
Figure 1: Position of the TBM's at the time the initial water level drop was noted on 3 May 2022

- 3.1.1 At the time when the incident was noticed, the TBM locations were as per Figure 1. The Upline TBM, Florence, was already 38 rings (76m) past the incident location, and the Downline TBM, Cecilia, was under the River Misbourne, but circa 20m downstream of the bridge.

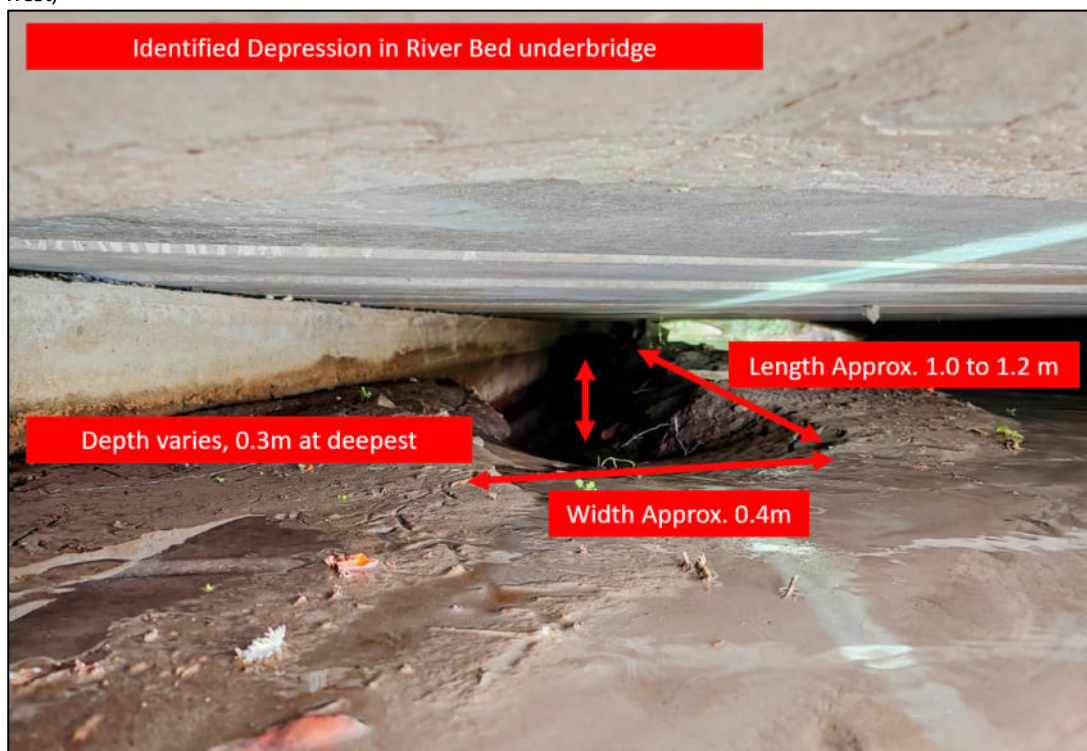
Figure 2 Photograph of the depression identified in the Misbourne Channel beneath Pheasant Hill Bridge (looking north-west)

1.1.4 The depression identified under the bridge is shown below in Figure 2. Due to the apex of the culvert being only about 0.4m above the riverbed, it was impossible to accurately gauge the dimensions of the feature, but it was estimated to be approximately 1.2m x 0.4m across, with a variable depth of up to 0.3m.

- 1.1.5 A drainage camera was inserted into the depression but the footage was unclear and did not provide any further information.
- 1.1.6 The riverbed under the bridge is heavily silted with fine material. The section of riverbed immediately upstream of the bridge has silt deposits approximately 0.3m deep in places. Downstream of the bridge, the riverbed is made up of larger stones and coarser material.

- 1.1.3 The depression was infilled on 6 May 2022 by placement of 7 bags of clay pellets and around 0.3m³ of chalk gravel, with further work carried out on 9 May 2022 consisting of an additional 0.1m³ of chalk gravel being added, followed by levelling out of the depression with silt from the riverbed itself. Thereafter, 2 further drops in water level were identified with no observable cause related to the TBM passage. The position of the TBMs at the time of the initial drop in water level are presented in Figure 1.

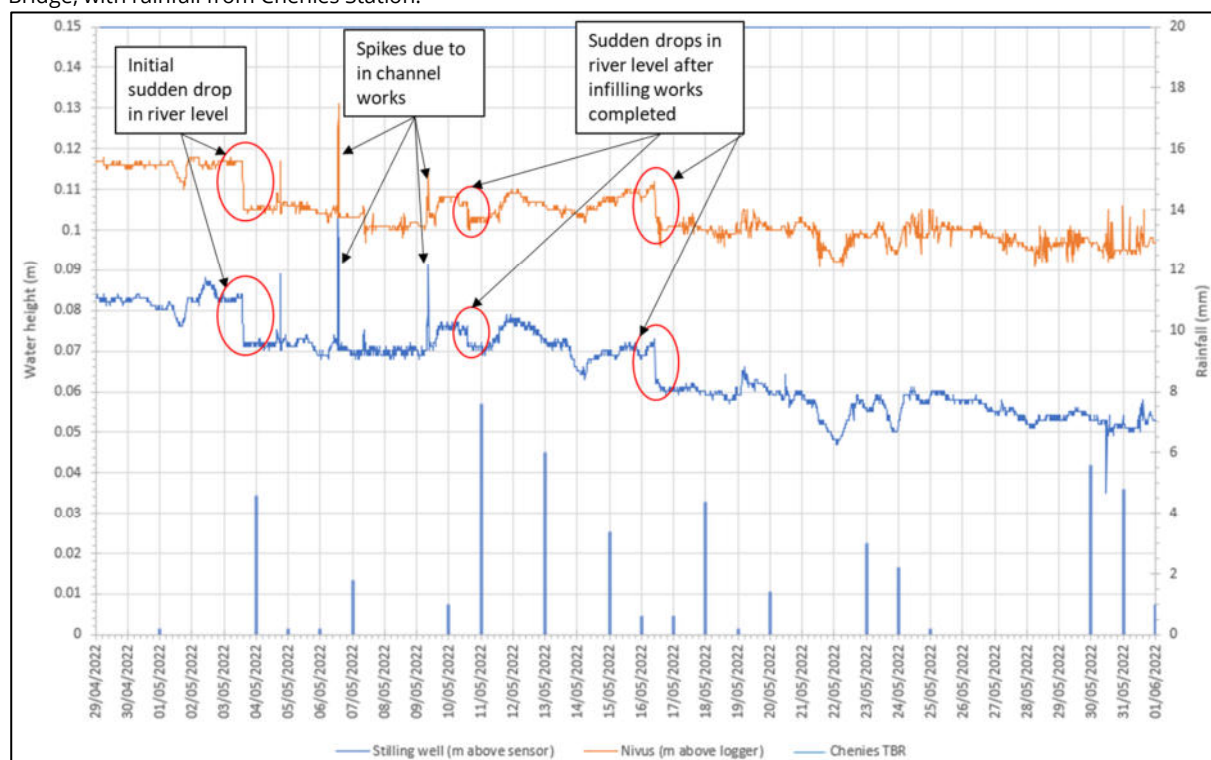
Figure 5: River water level data collected from flow gauge and stilling well installations directly below Pheasant Hill Bridge, with rainfall from Chenies Station.

2.1.5 The drop in water level which initially prompted the investigation was detected on 3 May 2022 between 13:30 and 14:45 (see Figure 5). At this time, TBM Florence had moved 76m beyond the incident location and TBM Cecilia was directly beneath the River Misbourne but circa 20m downstream of the bridge.

2.1.6 The drop in water level was recorded as 13mm and occurred over the course of 75 minutes. Water levels after this point remained relatively stable, with a short-term spike recorded on 4 May 2022 linked to rainfall and two further short term spikes on 6 May 2022 and 9 May 2022 which were linked to intervention works (see Figure 5).

2.1.7 After the intervention works on 9 May 2022, river levels rose slightly, before a further two sudden drops in water level were observed on 10 May 2022 and 16 May 2022 of 4mm and 11mm respectively. Water levels trended downwards over the rest of the month, in line with the expected seasonal

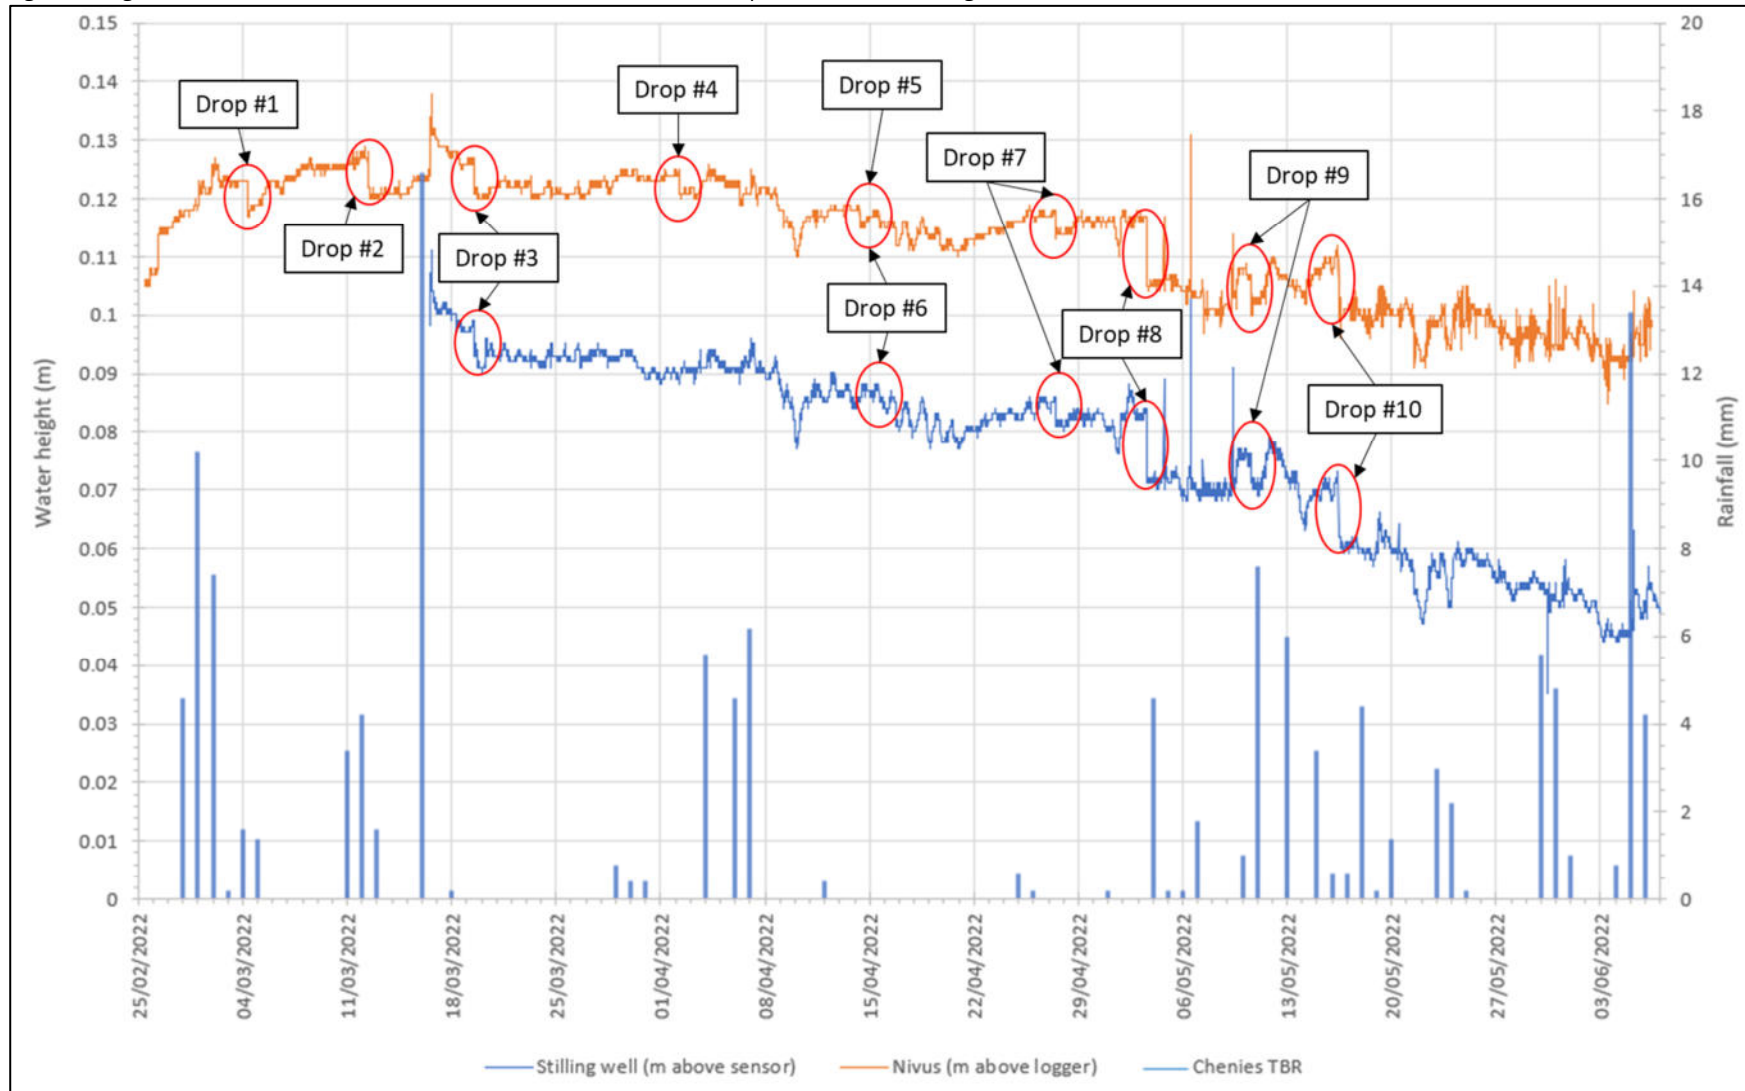
Figure 6: Align river level dataset with identified occurrences of sudden drops in water level, along with rainfall.

- 2.1.9 The drops in river level were typically of the order of 3 – 6mm and occurred over 30 – 60 minutes. The drop in level recorded on 3 May 2022 (as the TBMs were in the vicinity of the River Misbourne) was double this magnitude at 13mm, although a similar magnitude drop was recorded on 16 May 2022 when the TBMs had passed well beyond the crossing location.
- 2.1.10 The drops in river level were generally but not always present in data from both monitoring points, although, at the time of two of these events (4 and 12 March 2022) the stilling well was not operational.
- 2.1.11 A clear daily fluctuation in water level is observed in both sets of data, although it is not continuous through the data set, with periods of relatively steady water levels also recorded. These fluctuations do not coincide with rainfall events (shown on the Figure 6 below on the secondary axis).

- 4.1.2 In addition, sudden drops in river level occurring over a similarly short time frame of circa 30 – 75 minutes were recorded in the weeks before and after the TBMs had crossed the river (though generally of a smaller magnitude). This indicates that this response was evident before the transit of the TBMs beneath the River Misbourne and is not connected to TBM activity.

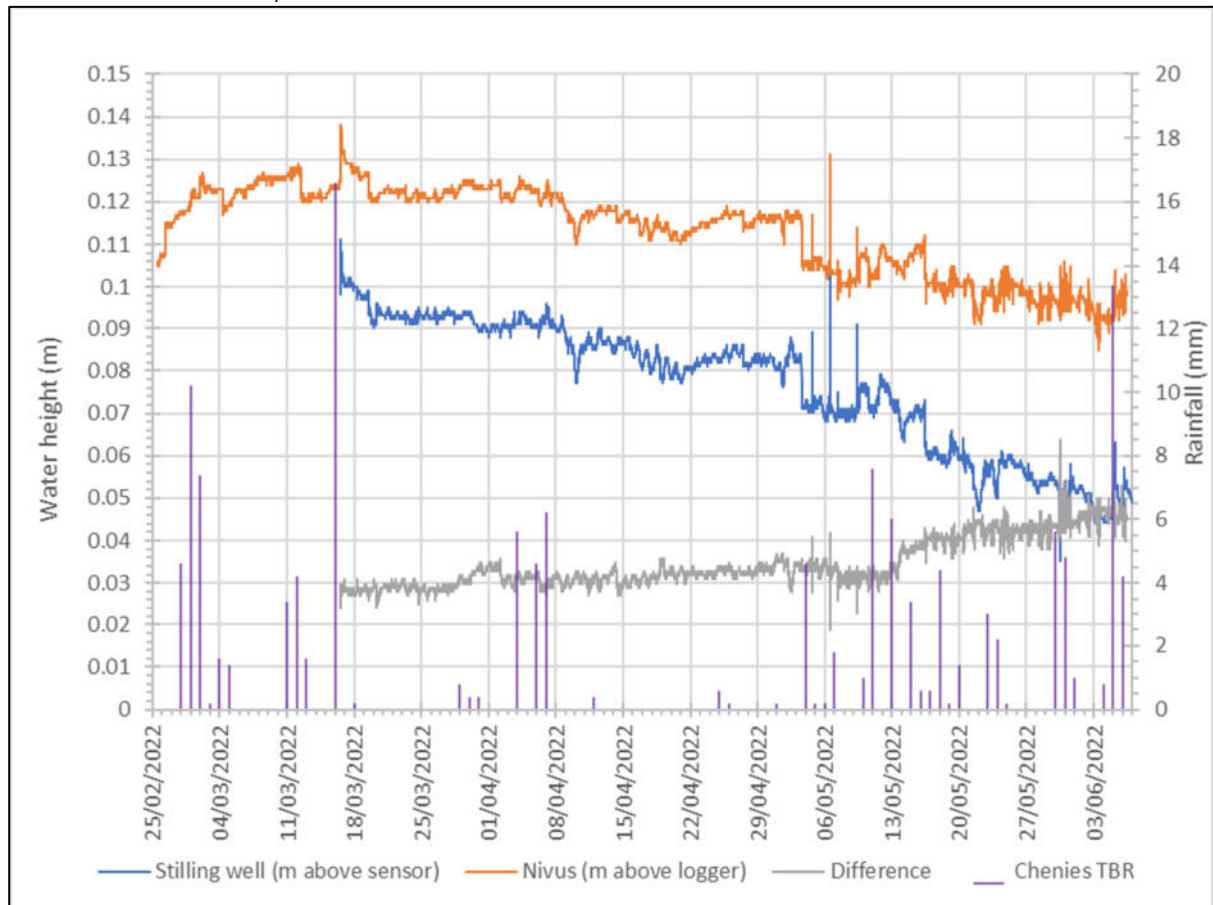
Figure 7: Calculated water level in the River Misbourne recorded by flow gauge (Nivus) and stilling well, with divergence between the two data sets plotted

2.1.12 The accuracy of the flow gauge decreases once less than 10cm of water is present in the river channel. From 16 May 2022 onwards, the water level recorded by the Nivus was consistently below the required 10cm of water. This is the likely cause of the increasing divergence observed between the two data sets from this point onwards (Figure 7) although this is after the TBMs have crossed beneath the River Misbourne.

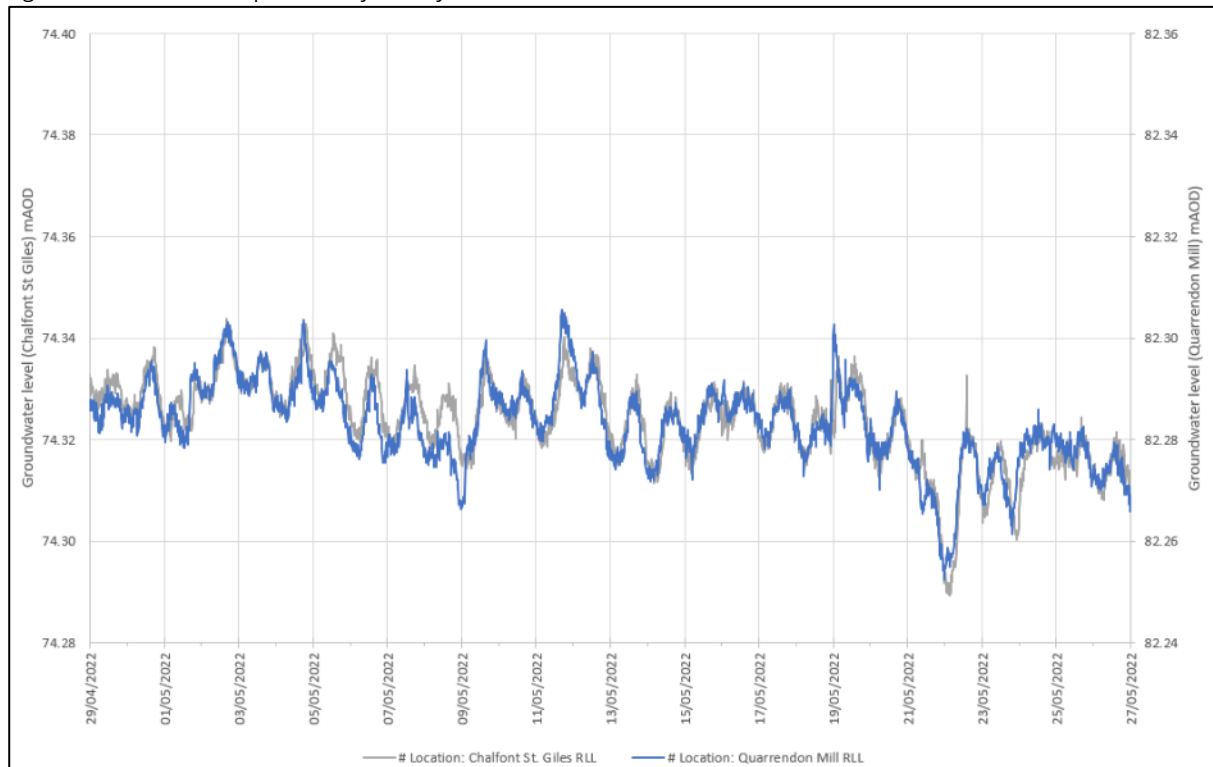
Figure 8: River level data provided by Affinity Water

2.1.13 In addition to the two water level monitoring locations operated by Align, data from river monitoring locations located up and down stream of the TBM crossing point have been obtained from Affinity Water and assessed. These river level monitoring points are Quarrendon Mill, located circa 3km up gradient of the TBM crossing point and Chalfont St Giles which is located circa 60m down gradient of the TBM crossing point (see Figure 3). Data covering the period of the TBM crossing is shown in Figure 8 and shows that the response in river level was very similar at both locations.

- 4.1.4 The river level data provided by Affinity Water (Figure 8) was in good agreement both up and down stream of the TBM crossing point over the entire period of interest and there was no indication of a sudden change in the river level or hydraulic characteristics of the river post TBM transit, as was picked up by the Align

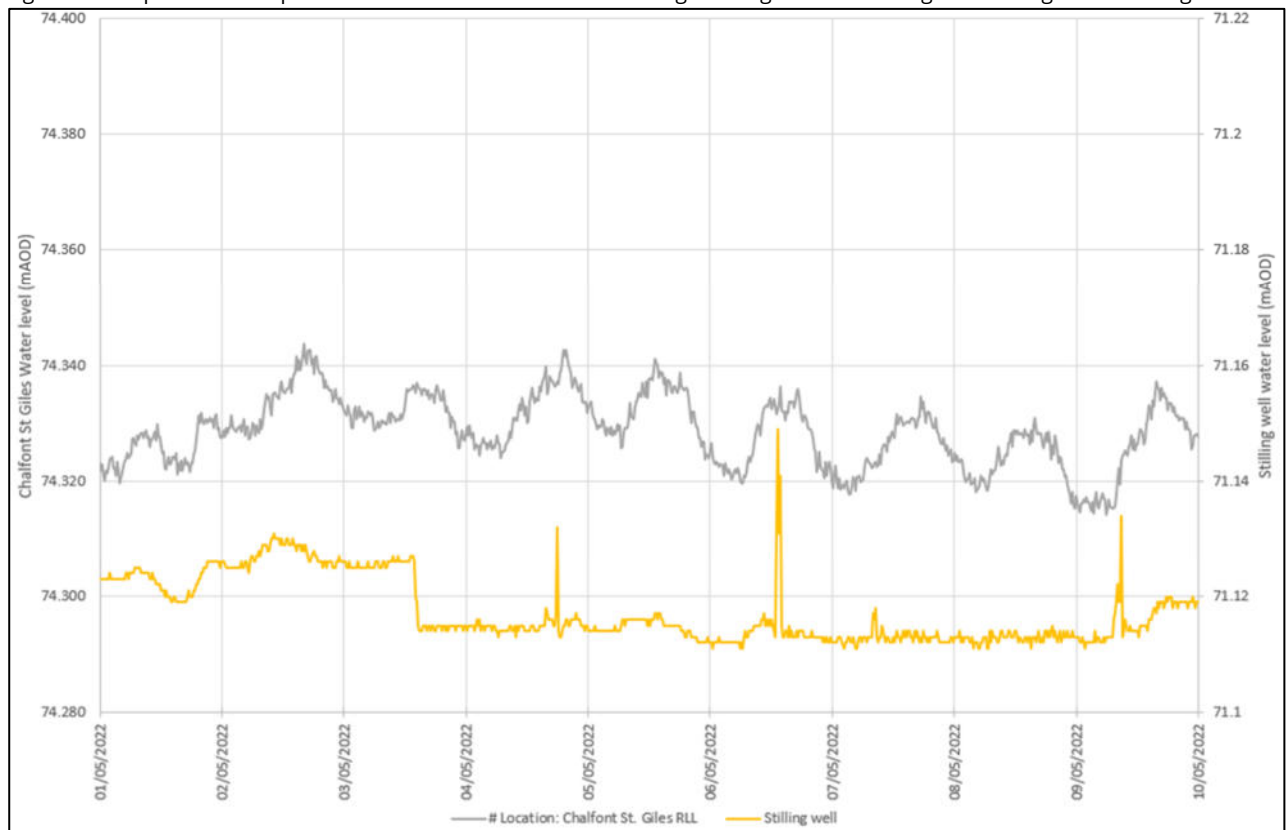
Figure 9: Comparison of response between Chalfont St Giles and Align Stilling well monitoring data during TBM crossing

2.1.14 The same diurnal fluctuations recorded in the Align data are evident in this data. However, there is no indication of a sudden step change in river level recorded in the Chalfont St Giles monitoring data during or after the transit of the river by the TBMs (Figure 9), as was indicated in the Align data.

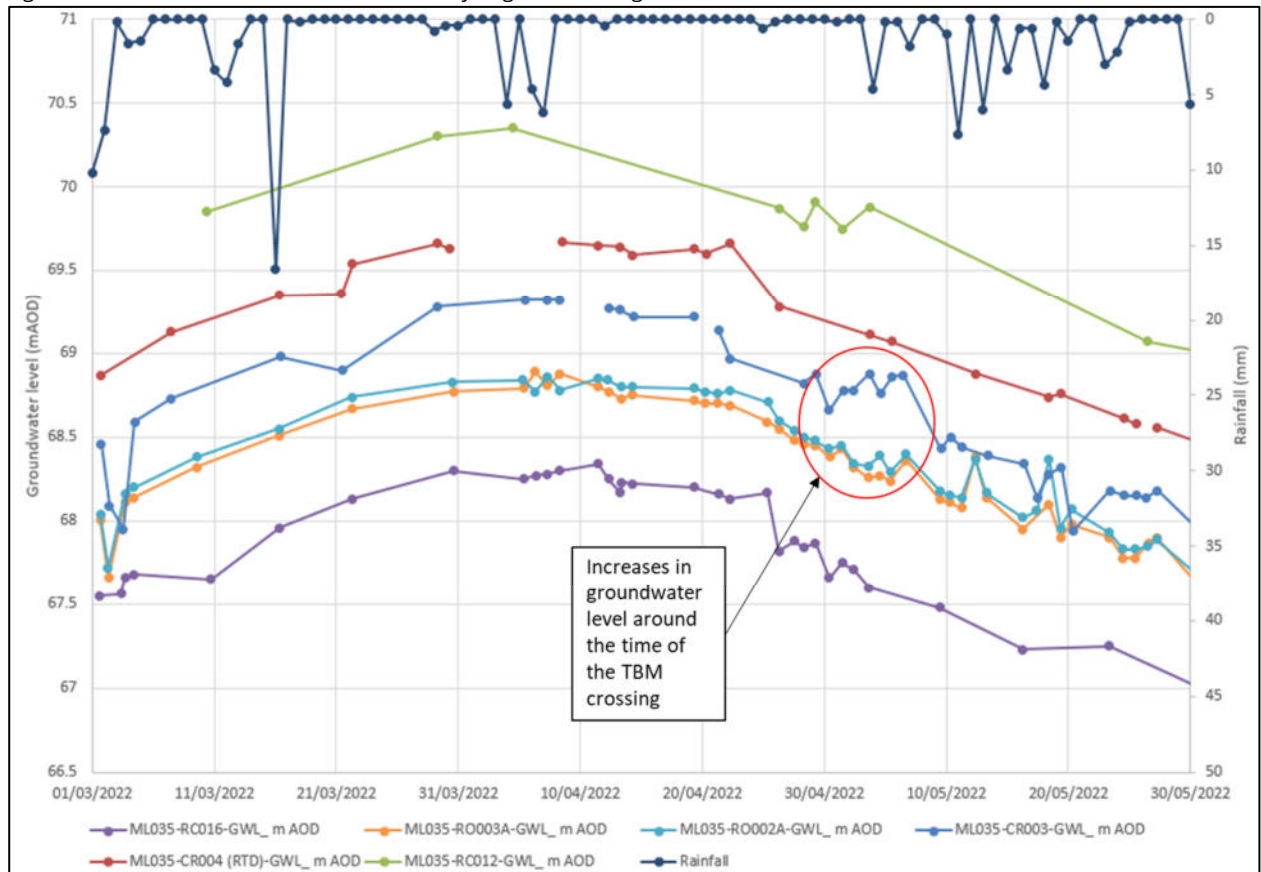
Figure 10: Groundwater level data from nearby Align monitoring boreholes

- 2.1.15 Groundwater level data from the nearby Align monitoring boreholes are presented in Figure 10 with their locations presented in Figure 3. These data show the groundwater level peak to have occurred some time in early April 2022 with water levels slowly decreasing from that point for the remaining monitoring period. At the time of the TBM crossing (between 30 April and 9 May 2022) groundwater levels in locations nearest to the river (ML035-RO002A, ML035-RO003A and ML035-CR003) were circa 68.5mAOD, some 5.5 - 6m below the water level in the river as reported by the Chalfont St Giles river level station (circa 74.3 m AOD).

- 2.1.16 Some minor increases in water level are recorded in ML035-RO002A and ML035-RO003A (located circa 50m and 65m down gradient of the TBM crossing point respectively) around the time of the TBM crossing. A similar response is recorded over this time period in ML035-CR003 and ML035-RC012 which are located circa 130m and 500m up gradient of the TBM crossing point.

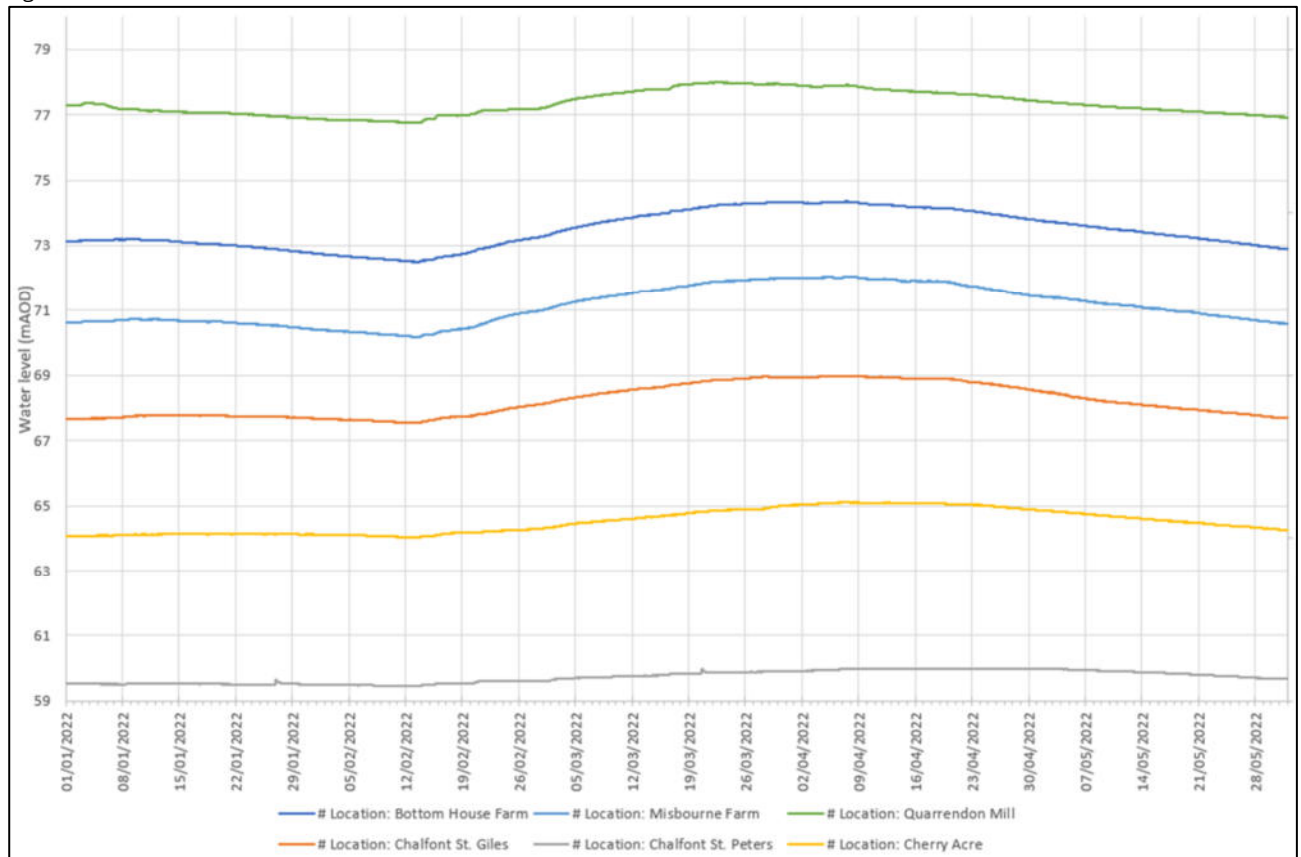
Figure 11: Groundwater level data from EA observation boreholes

2.1.17 In addition, groundwater level data from nearby EA observation boreholes have been reviewed and are presented in Figure 11. The tunnel crown is at circa 53m AOD at the tunnel crossing point.

2.1.18 None of the observation boreholes indicate a significant increase in groundwater level that coincides with the transit of the TBMs. Groundwater levels all show a gradual decline with good agreement in the rate of recession across all locations. There are some slight fluctuations evident in water level readings at the Chalfont St Giles borehole located circa 60m down gradient of the crossing location which correlate with the period of the TBM crossing (see Figure 12) and are not present before or after. Groundwater levels at Chalfont St Giles after the TBMs have crossed the Misbourne behave in a similar way to the other groundwater monitoring locations and continue to gradually decline.

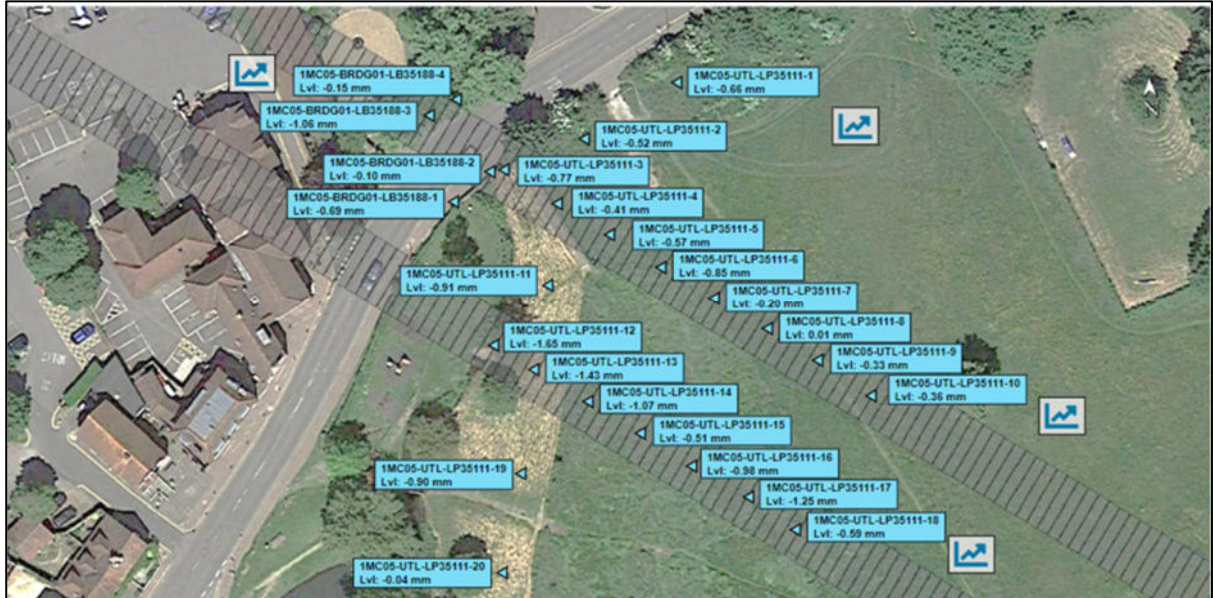
Figure 13: Monitoring conditions of the Bridge, the utilities and TBM alignment as of 4 May 2022

3.1.5 Maximum settlement under the upline was 1.06mm at the bridge location, and maximum settlement below the downline was 1.65mm just before the river crossing.

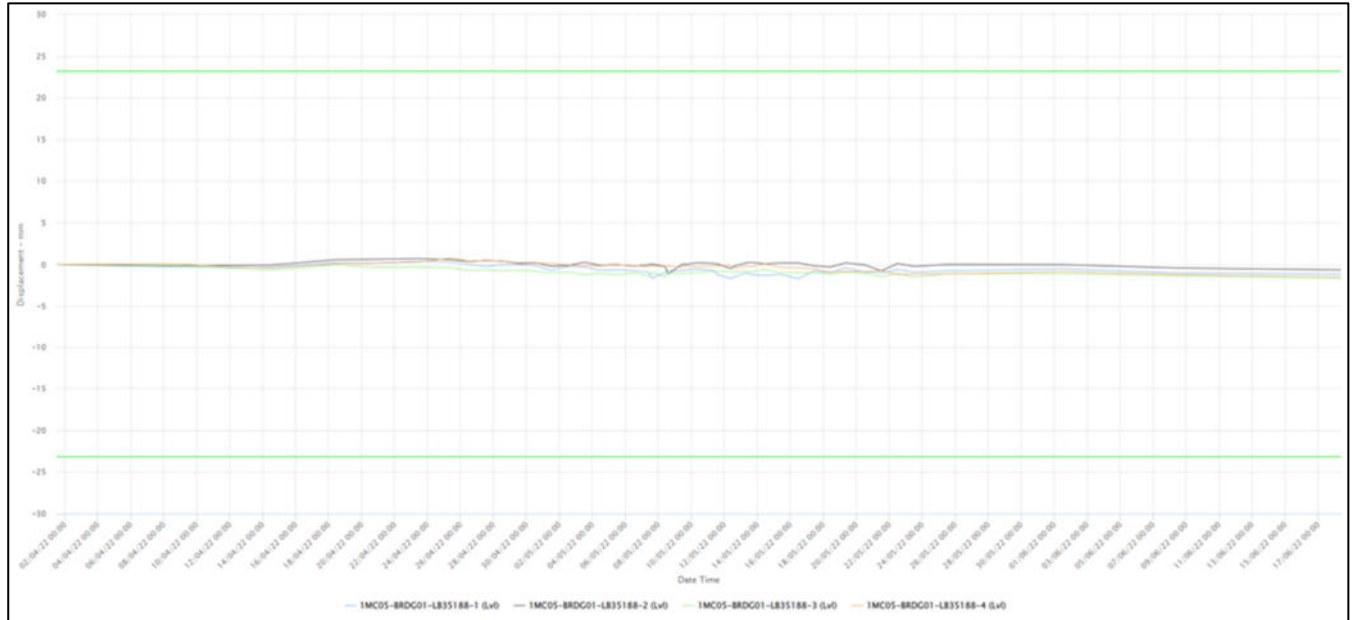
Figure 15: Monitoring of the bridge for the period of 1 April to 18 June 2022

3.1.7 Figure 15 below shows the bridge monitoring for the period from 1 April 2022 to the latest reading to date, 18 June 2022. The readings remain stable and are well within the green monitoring condition ($\pm 23\text{mm}$).

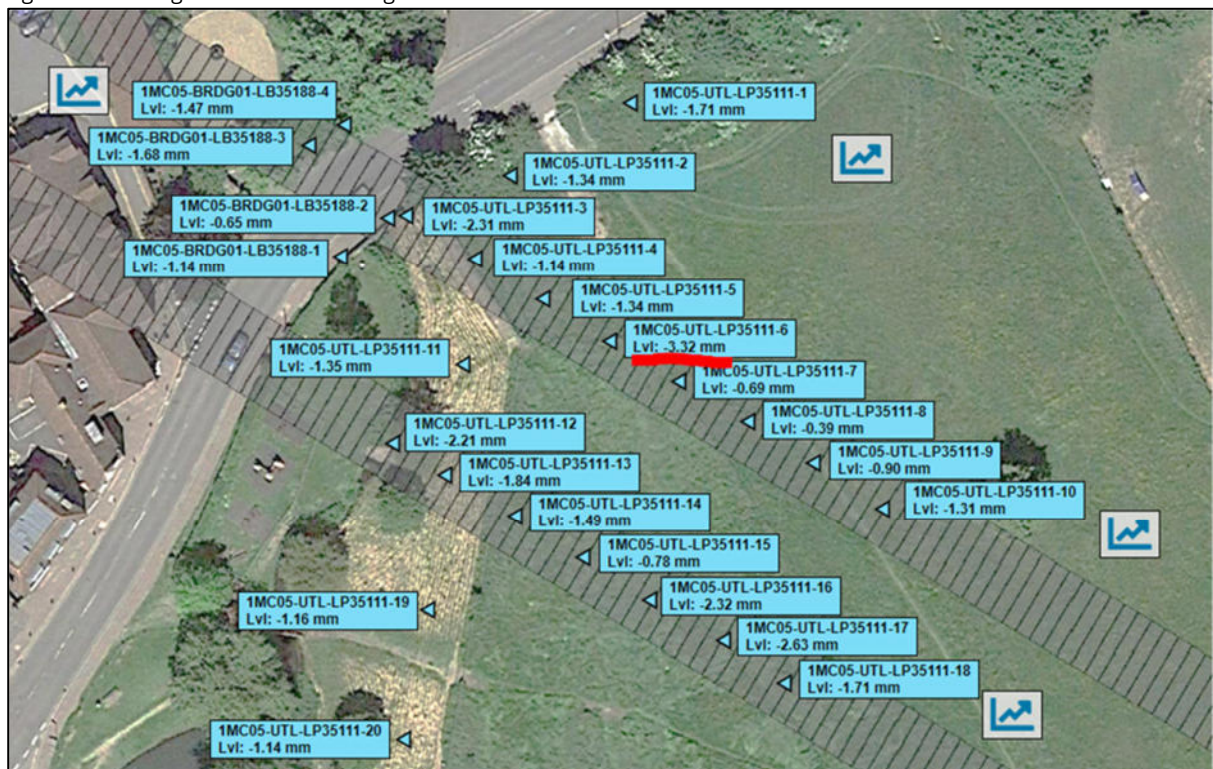
Figure 16 Readings of the area showing maximum recorded settlement of 3.32mm

3.1.8 Based on the results, the biggest movement observed throughout the whole area is 3.32mm, above the upline tunnel, approximately 40m downgradient of the incident location.

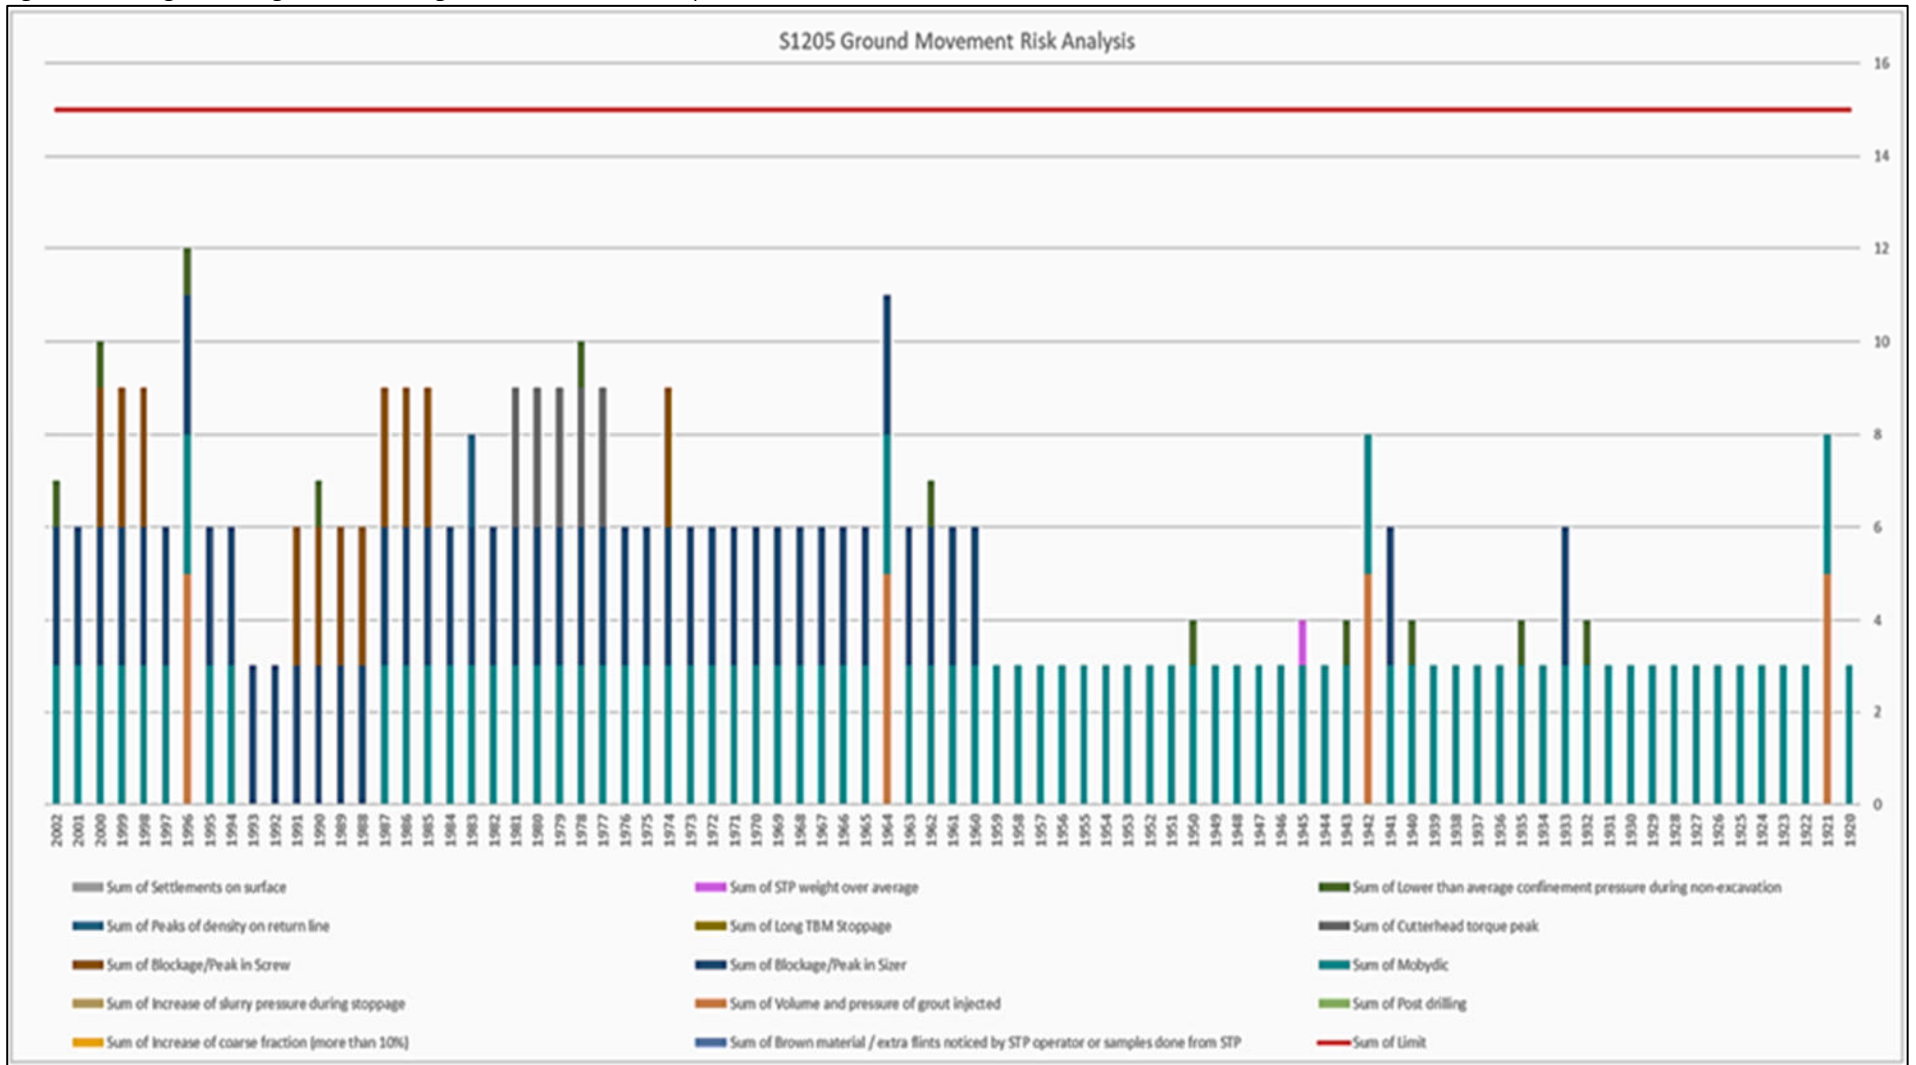
Figure 17 Scoring of the rings based on the ground movement action plan

- 3.1.9 As per the current ground movement action plan several TBM parameters have been identified as potentially indicating the crossing of a dissolution feature. They are reviewed daily and each ring is scored according to the breach of the parameter triggers (abnormally high STP weight, poor Mobydic readings, high sizer or screw torque etc.). If a score is >15/49, a MAT meeting is called to decide upon further actions.
- 3.1.10 Figure 17 below shows the scoring of the rings for the period of interest – the ring being excavated at the time the incident happened is UR1970, so the parameters corresponding to that ring have been considered. The score of that ring is 6/49, so well below the trigger level for concern.

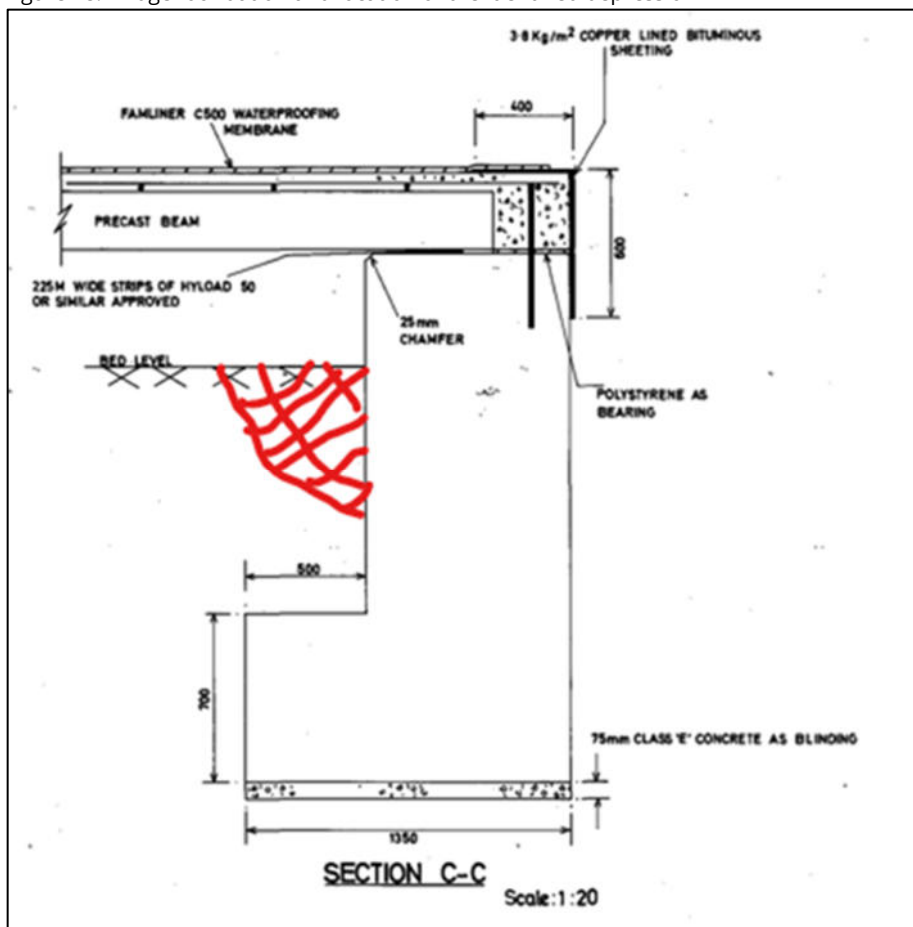
Figure 18: Bridge foundation and location of the identified depression

*Red hatched area indicates approximate location of depression (not to scale)

- 3.1.13 The foundation of the bridge is in an "L" shape, with the depression that has been identified above the horizontal bar of the "L". The location of the depression is therefore difficult to link to the TBM activity given that the foundation would offer protection against deep rooted subsidence.

- 3.1.14 Due to its location, the depression under this small bridge could easily have been missed during the pre-construction period, so there is a distinct possibility that it was pre-existing prior to the passing of the TBMs.
