Incident Report: Crossing of the River Misbourne by the Chiltern Tunnel.

1MC05-ALJ-EV-REP-CS02_CL04-000228

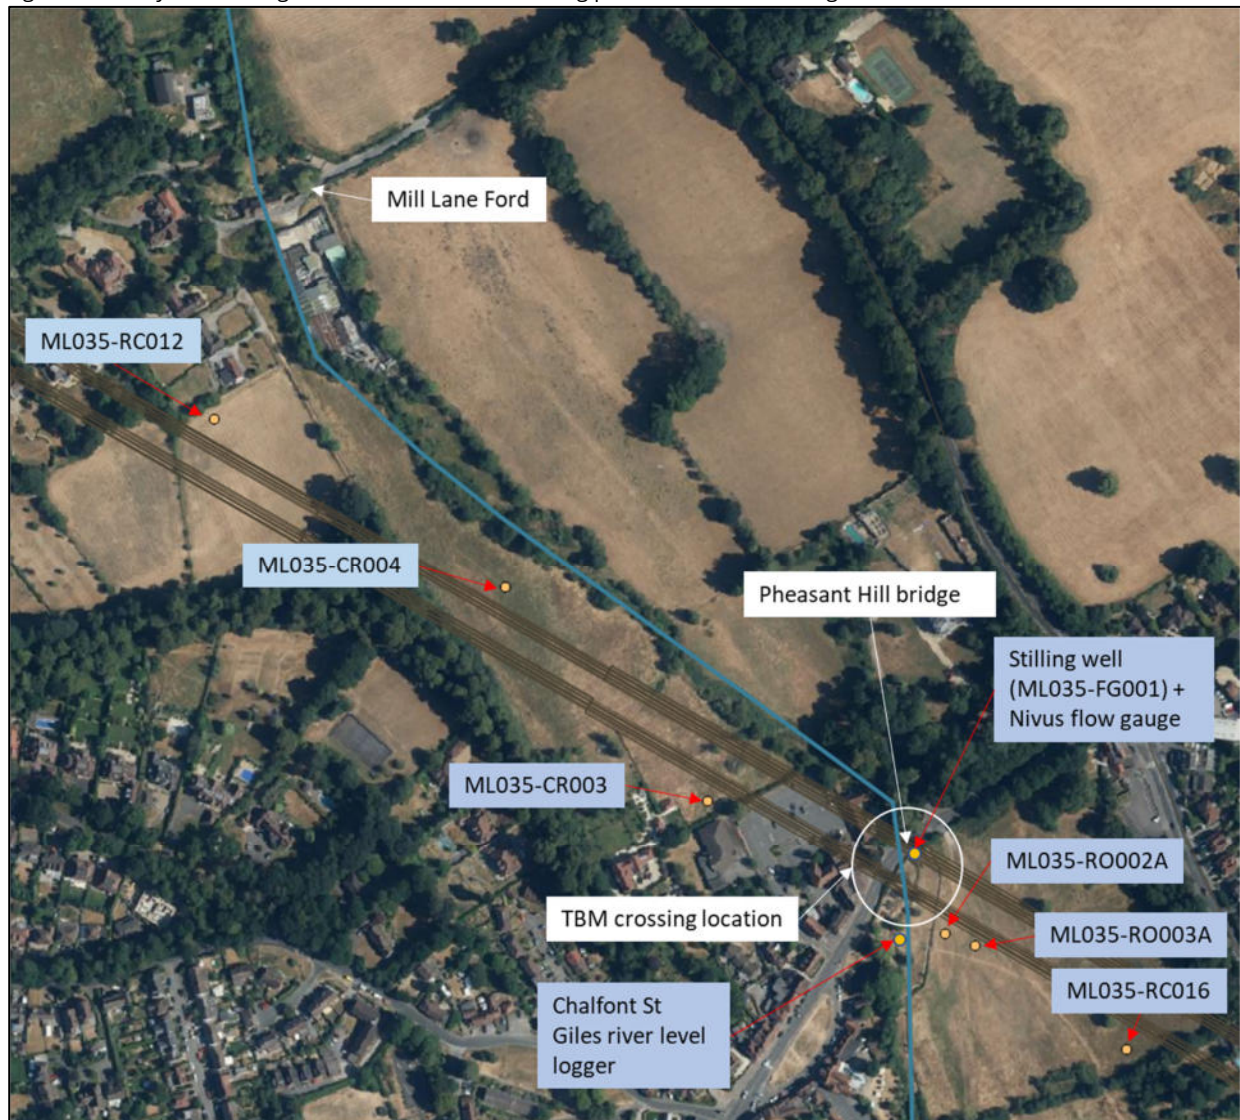
Figure 3: Site layout showing locations of water monitoring points and TBM crossing location

1.1.7 An investigation of the upstream river was conducted during May 2022. The land directly upstream of the crossing point (see Figure 3) is agricultural and used for grazing with cattle and sheep known to have direct access to the river approximately 175m upstream of the bridge. Further upstream, the river meanders through fields, with brush and trees on either side of the bank. Approximately 580m upstream the Misbourne is crossed by Mill Lane through a ford.

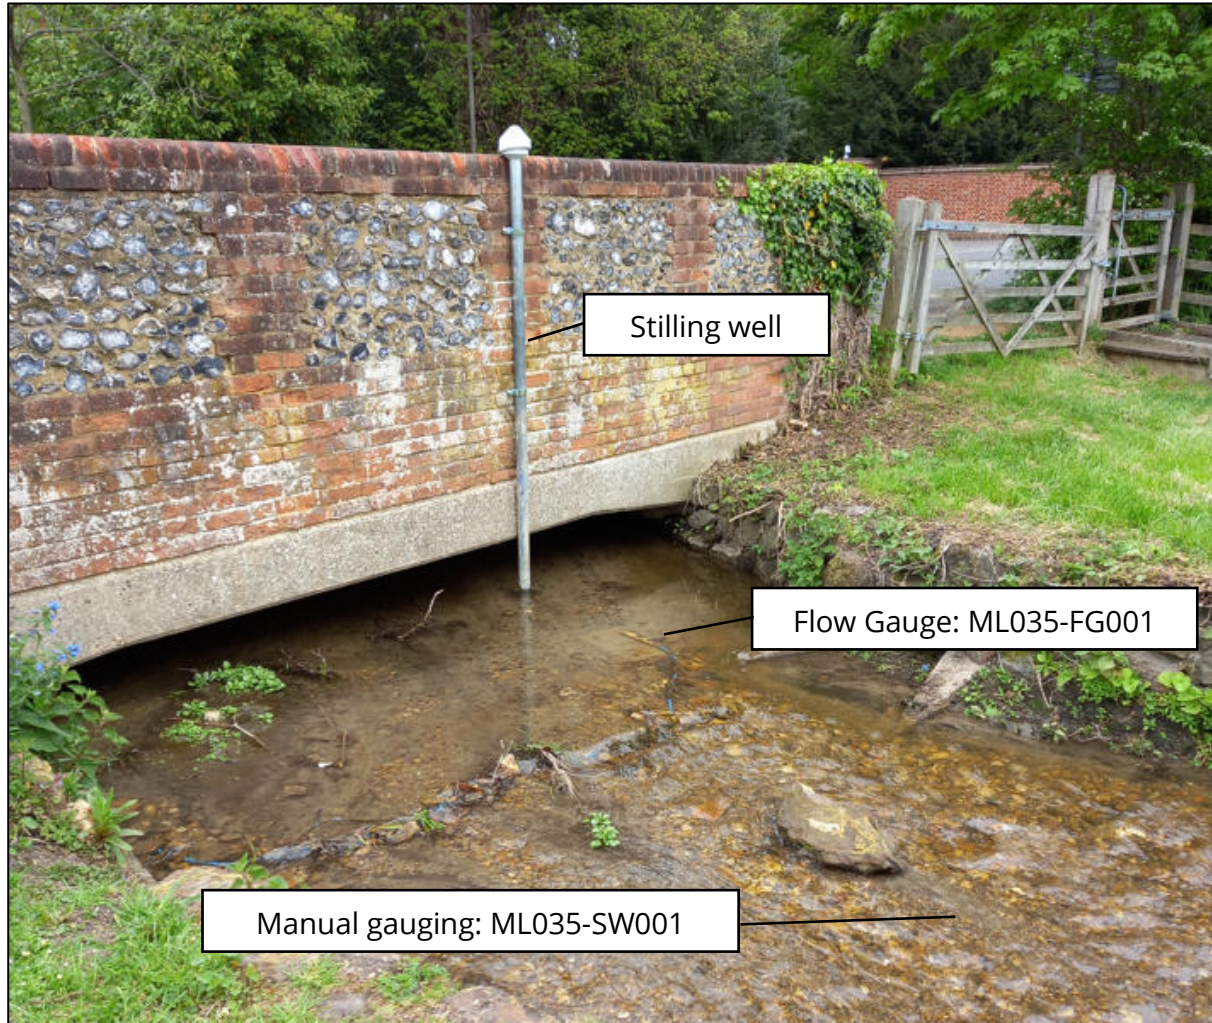
Figure 4: Photograph of monitoring points ML035-SW001 (stilling well installation and manual flow gauging point) and ML035-FG001 (flow gauge installation)

- 2.1.1 Water level data from the River Misbourne is recorded by Align at 2 separate installations at Chalfont St Giles (Figure 3). The first is a stilling well installed on the downstream side of the bridge, and the second a Nivus flow gauge (from which water level is calculated) installed in the riverbed about 1m downstream of the bridge (Figure 4).

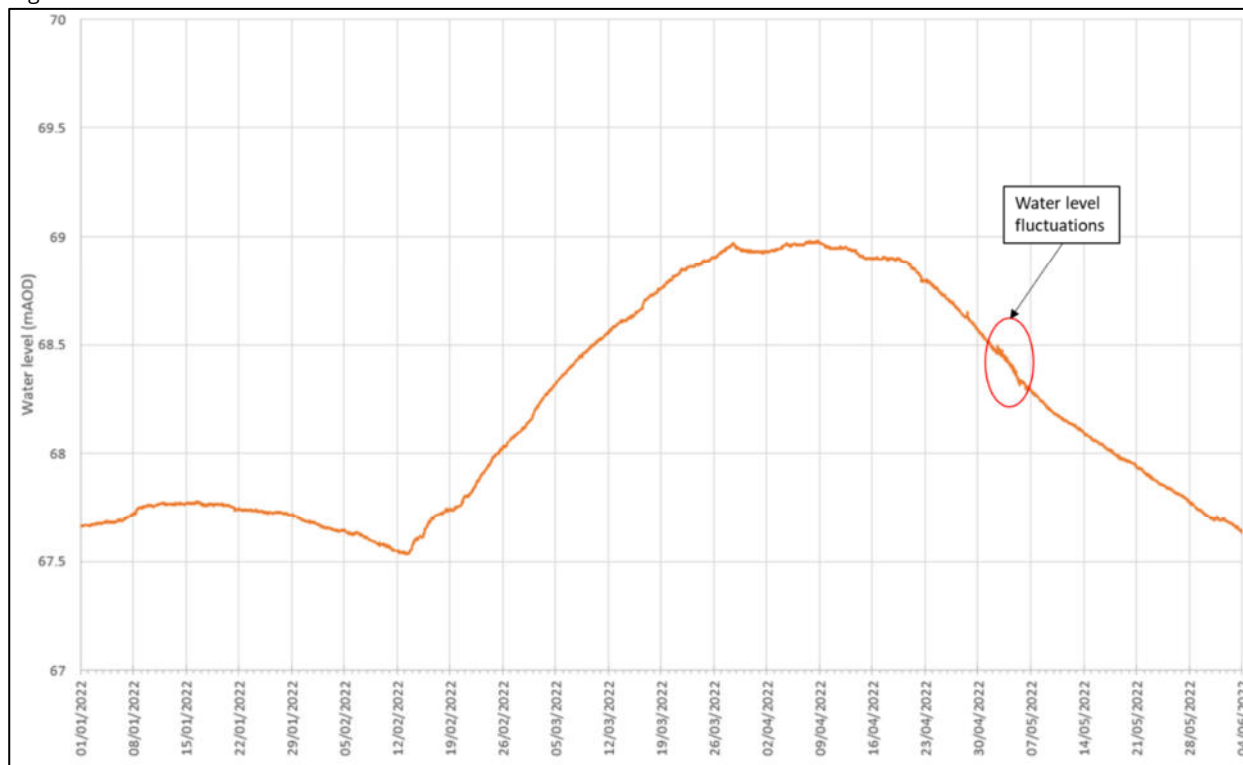
Figure 12: Groundwater level data from Chalfont St Giles observation borehole

2.1.18 None of the observation boreholes indicate a significant increase in groundwater level that coincides with the transit of the TBMs. Groundwater levels all show a gradual decline with good agreement in the rate of recession across all locations. There are some slight fluctuations evident in water level readings at the Chalfont St Giles borehole located circa 60m down gradient of the crossing location which correlate with the period of the TBM crossing (see Figure 12) and are not present before or after. Groundwater levels at Chalfont St Giles after the TBMs have crossed the Misbourne behave in a similar way to the other groundwater monitoring locations and continue to gradually decline.

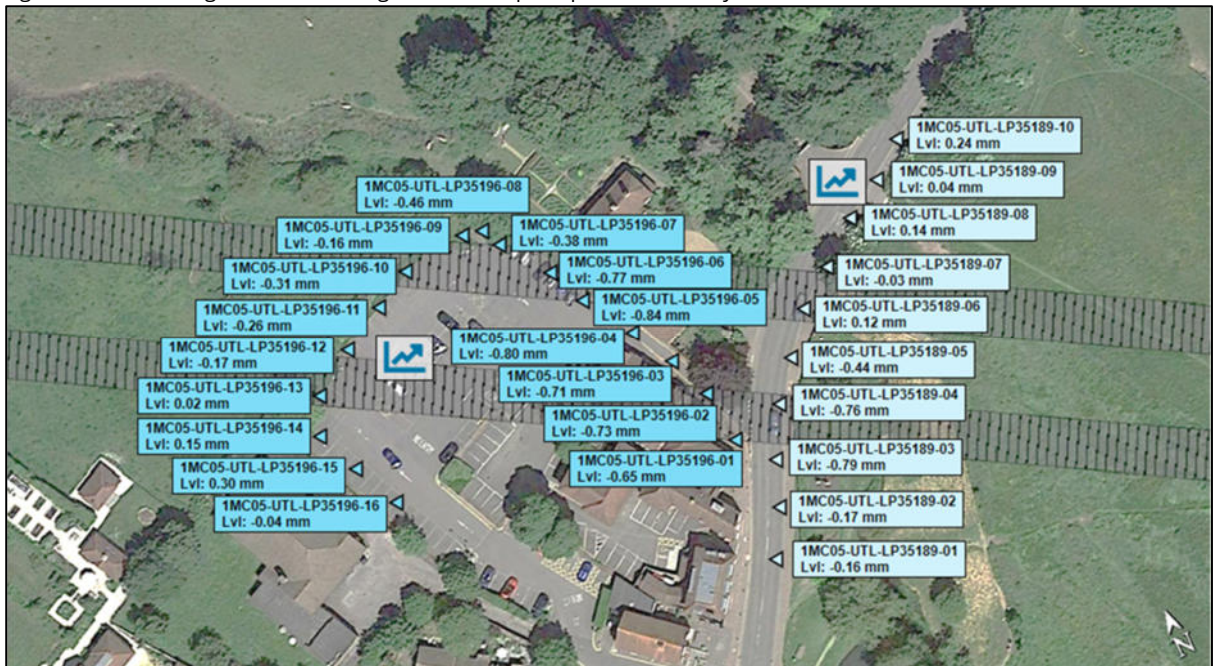
Figure 14: Monitoring conditions of High St and Coop car park as of 4 May 2022

- 3.1.4 As of 11.00am on 4 May 2022, the readings were as per Figure 13 and Figure 14 below.

3.1.6 Following the incident, and as a result of the Management Action Team (MAT) meeting held, the monitoring frequency was increased to twice daily for a period of one week. On the basis of no further movement, it was decreased to daily measurements for another 10 days, and then back to the normal monitoring weekly readings.
